## **TAMU Project**

**Energy Consumption Data Quality Assurance/Quality  
Control Assessment Report for the  
Month of October 2017**

**Utility & Energy Services  
Division of Administration  
Texas A&M University**

**November 2017**

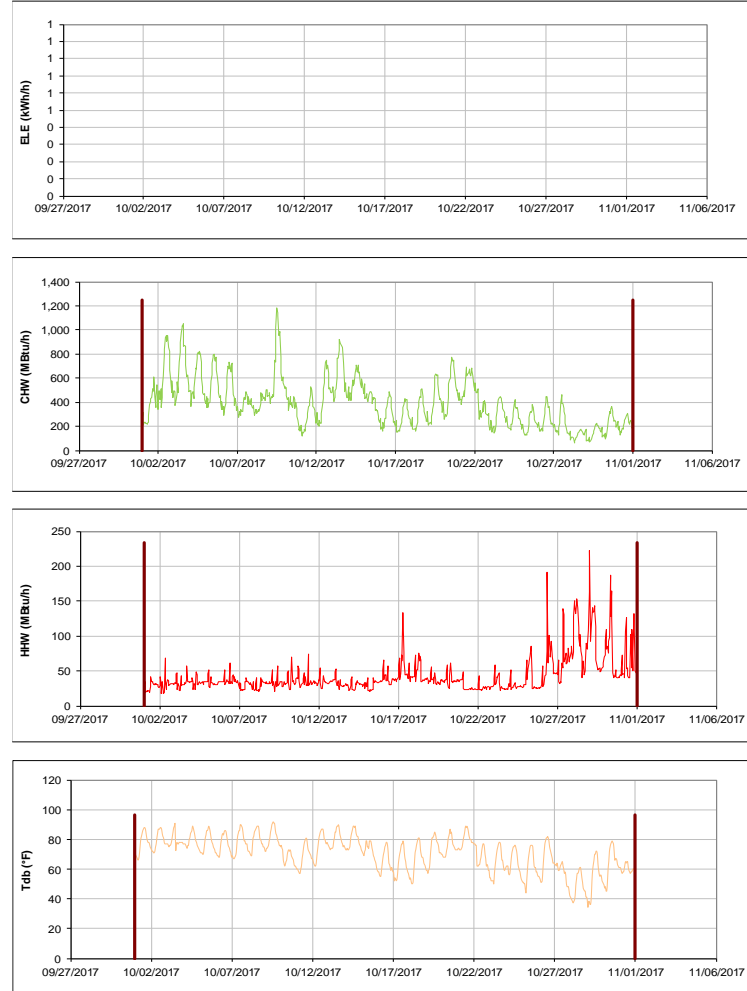
TAMU / BLDG #: 0445

Figure III-63 Hourly Whole Building Electricity, Chilled Water, and Hot Water Consumption for Teague Research Center during the Month of October 2017 and the Corresponding Hourly Outdoor Dry Bulb Temperature for College Station, TX

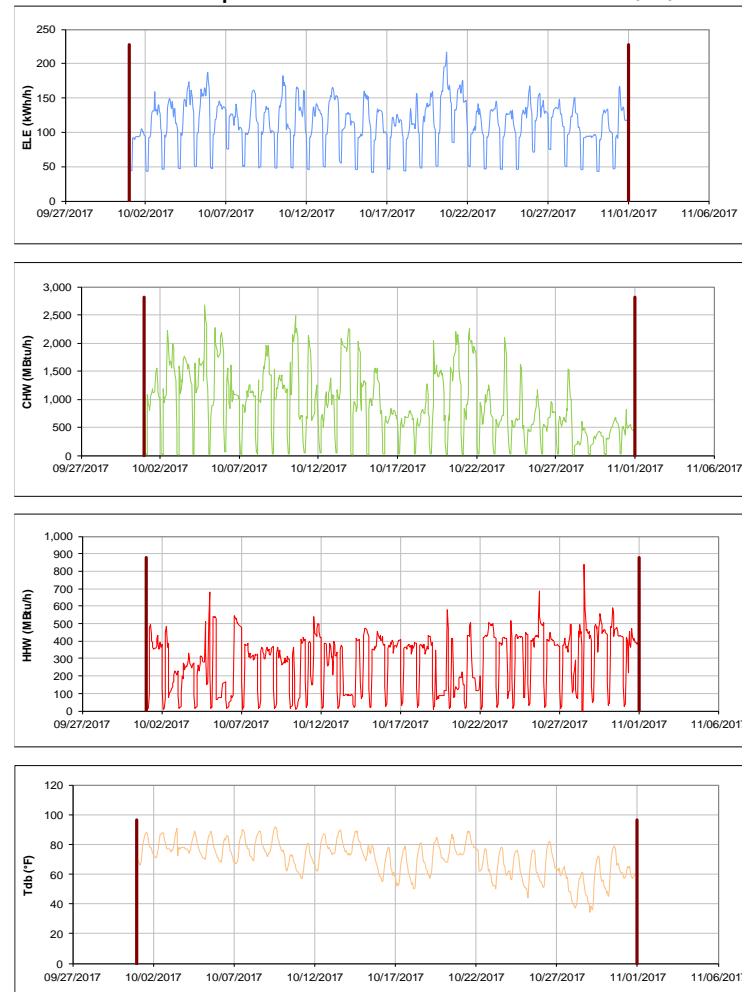
TAMU / BLDG #: 0446-A

Figure III-66 Hourly Whole Building Electricity, Chilled Water, and Hot Water Consumption for Rudder Theatre Complex during the Month of October 2017 and the Corresponding Hourly Outdoor Dry Bulb Temperature for College Station, TX

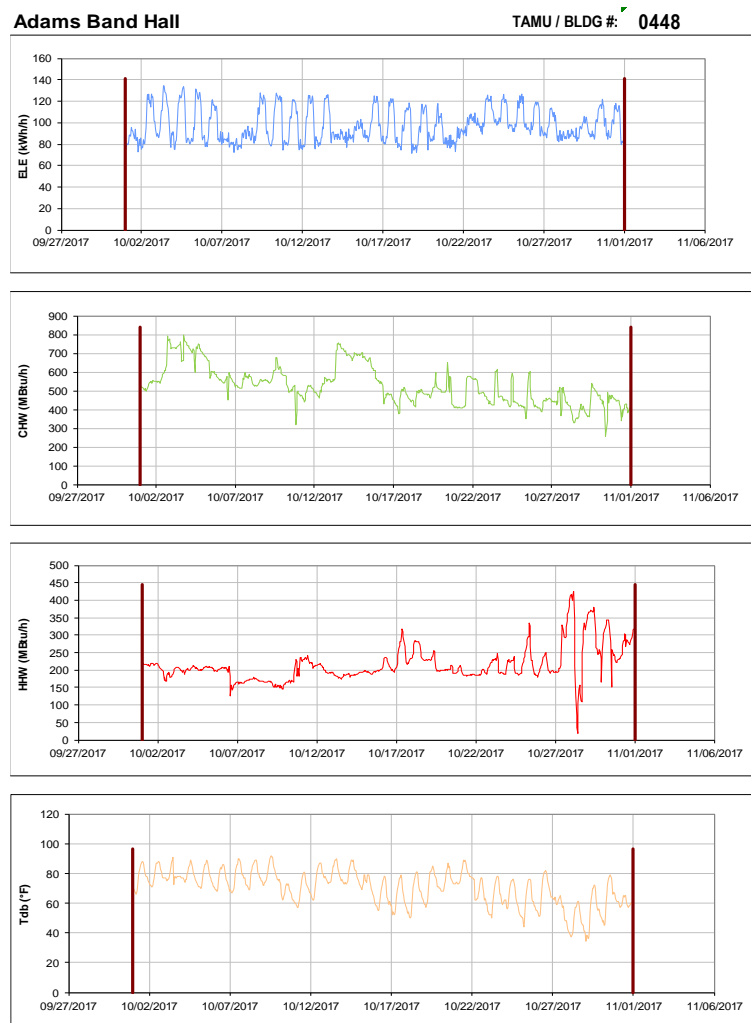
Figure III-69 Hourly Whole Building Electricity, Chilled Water, and Hot Water Consumption for Adams Band Hall during the Month of October 2017 and the Corresponding Hourly Outdoor Dry Bulb Temperature for College Station, TX

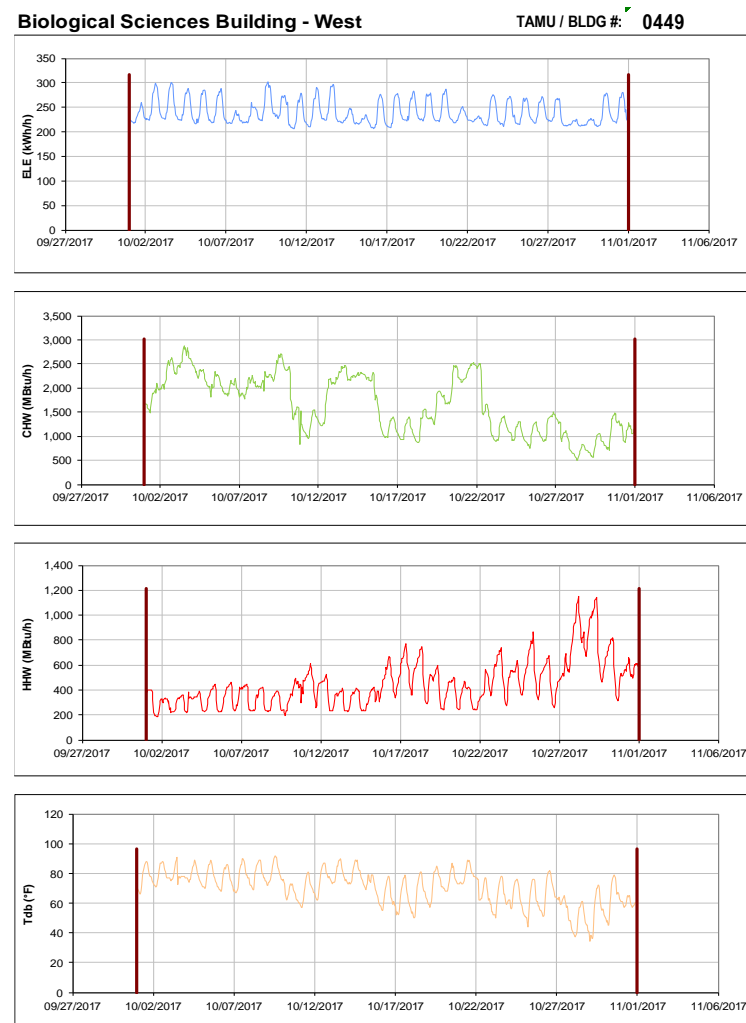
Figure III-70 Hourly Whole Building Electricity, Chilled Water, and Hot Water Consumption for Biological Sciences Building - West during the Month of October 2017 and the Corresponding Hourly Outdoor Dry Bulb Temperature for College Station, TX

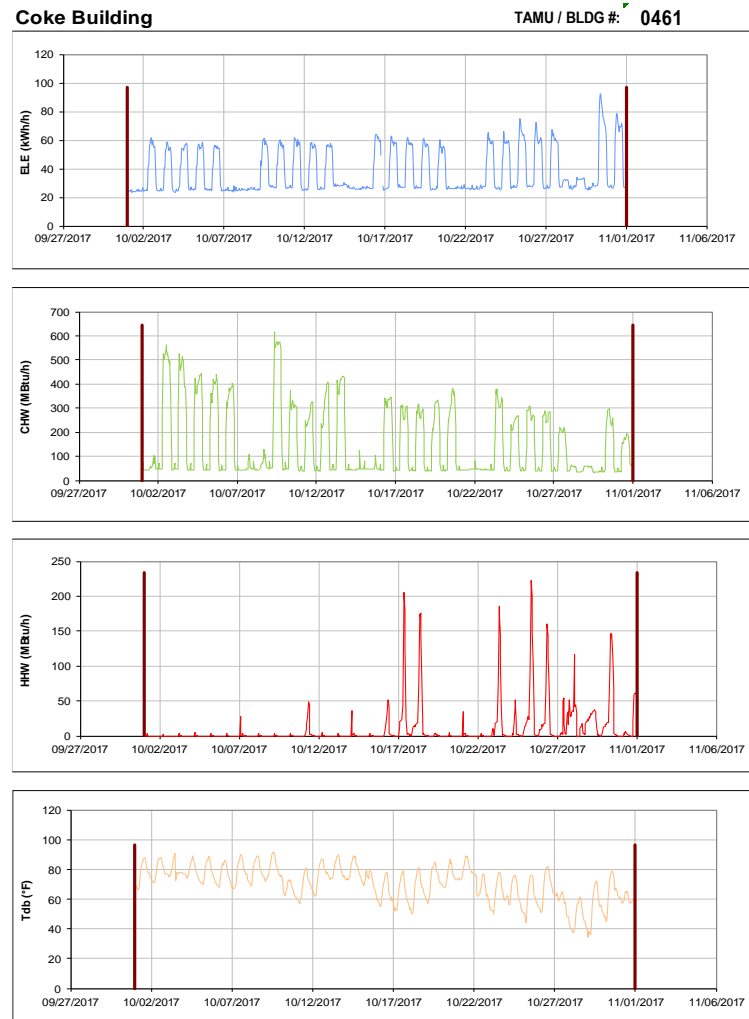
Figure III-75 Hourly Whole Building Electricity, Chilled Water, and Hot Water Consumption for Coke Building during the Month of October 2017 and the Corresponding Hourly Outdoor Dry Bulb Temperature for College Station, TX

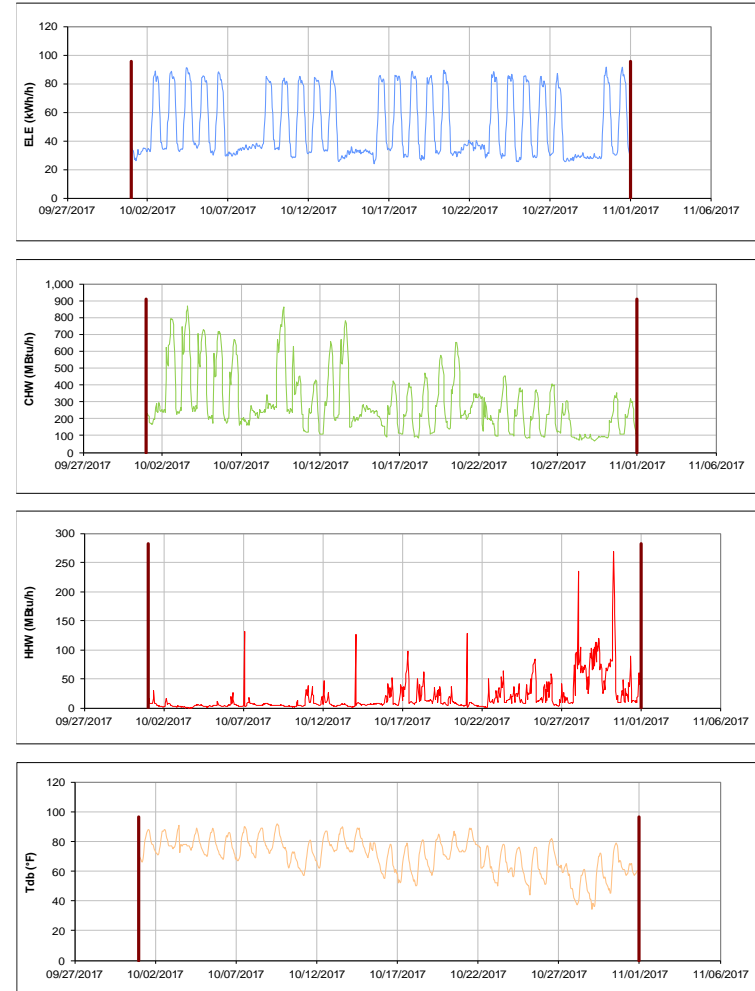
TAMU / BLDG #: 0471

Figure III-84 Hourly Whole Building Electricity, Chilled Water, and Hot Water Consumption for Pavilion during the Month of October 2017 and the Corresponding Hourly Outdoor Dry Bulb Temperature for College Station, TX

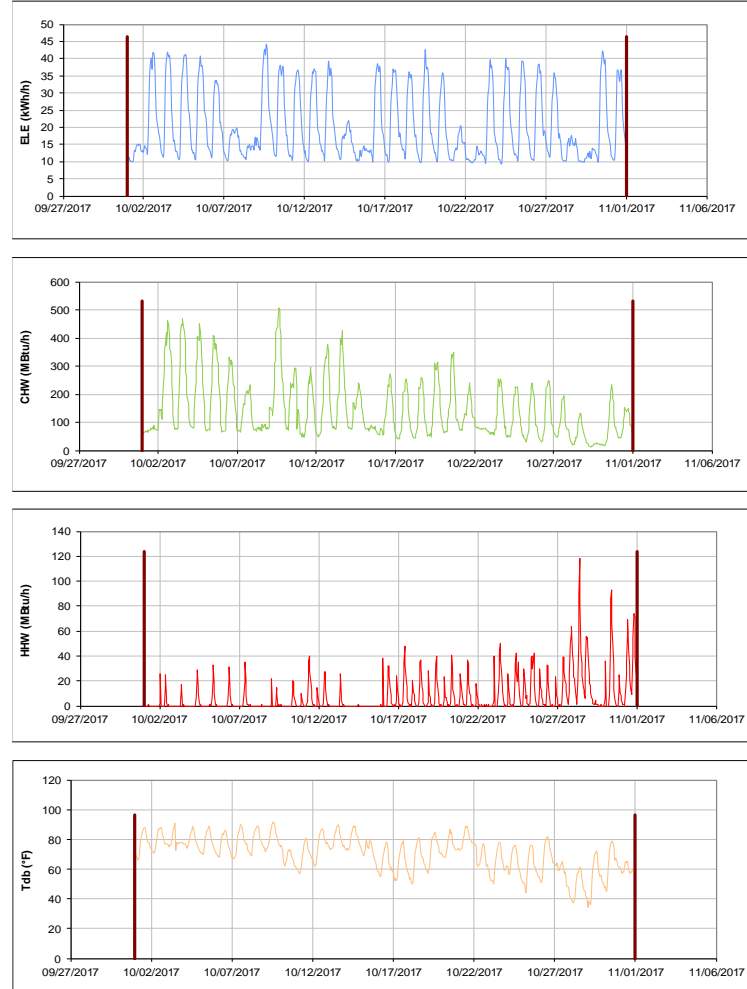
TAMU / BLDG #: 0482

Figure III-93 Hourly Whole Building Electricity, Chilled Water, and Hot Water Consumption for Fermier Hall during the Month of October 2017 and the Corresponding Hourly Outdoor Dry Bulb Temperature for College Station, TX

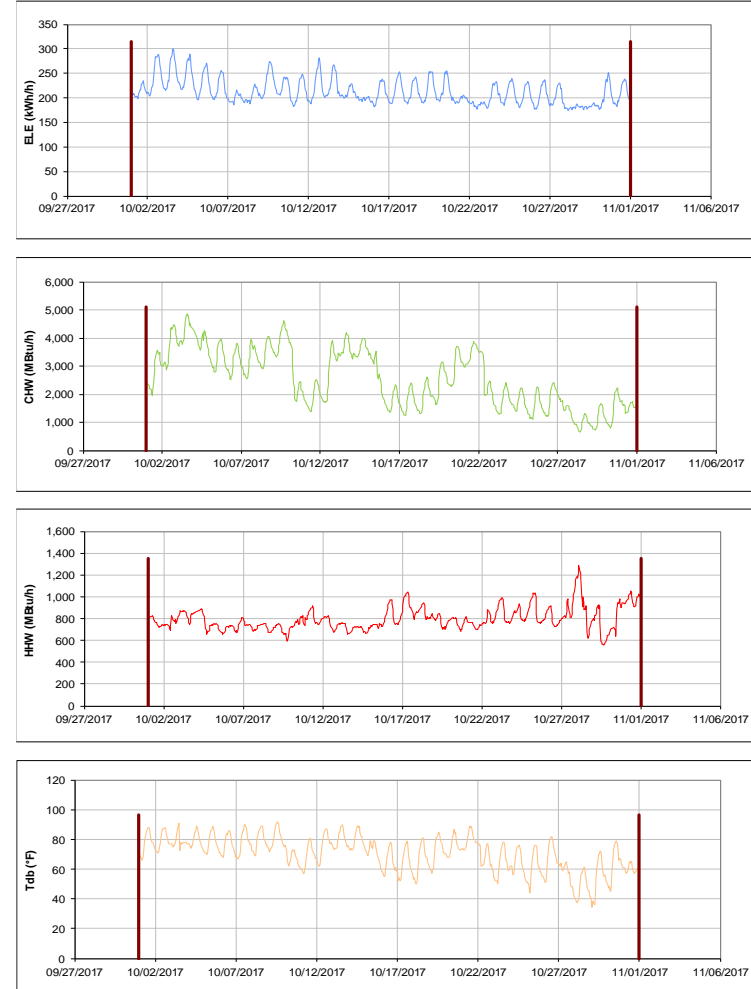
TAMU / BLDG #: 0490

Figure III-96 Hourly Whole Building Electricity, Chilled Water, and Hot Water Consumption for Halbouty Geosciences Building during the Month of October 2017 and the Corresponding Hourly Outdoor Dry Bulb Temperature for College Station, TX

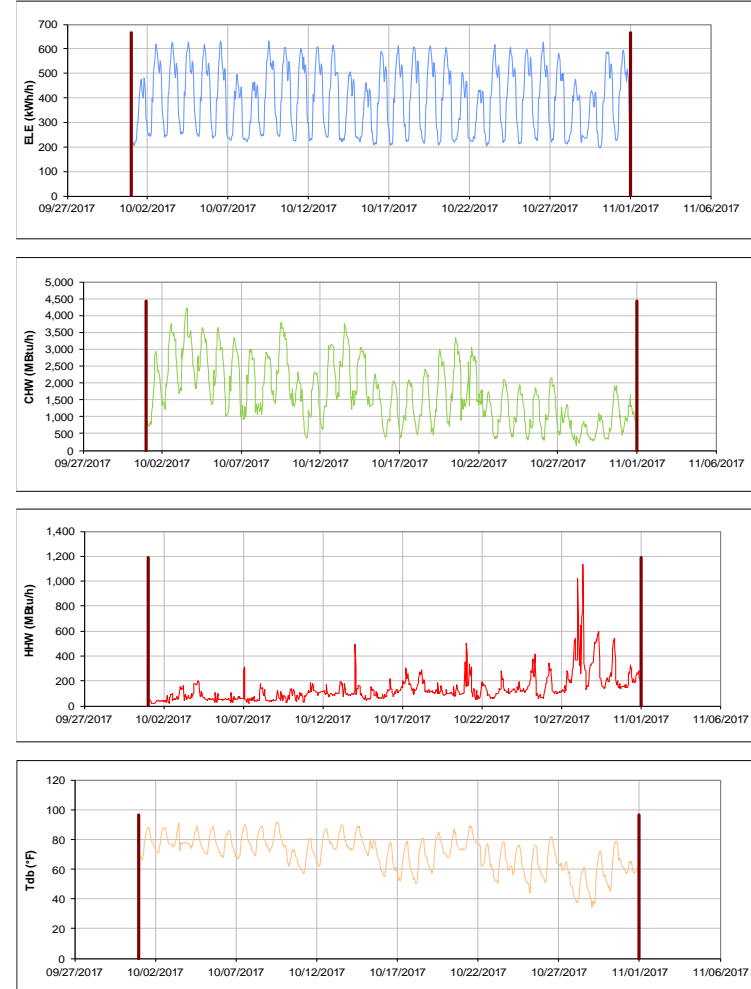
TAMU / BLDG #: 0495

Figure III-98 Hourly Whole Building Electricity, Chilled Water, and Hot Water Consumption for Sbisa Dining Hall during the Month of October 2017 and the Corresponding Hourly Outdoor Dry Bulb Temperature for College Station, TX

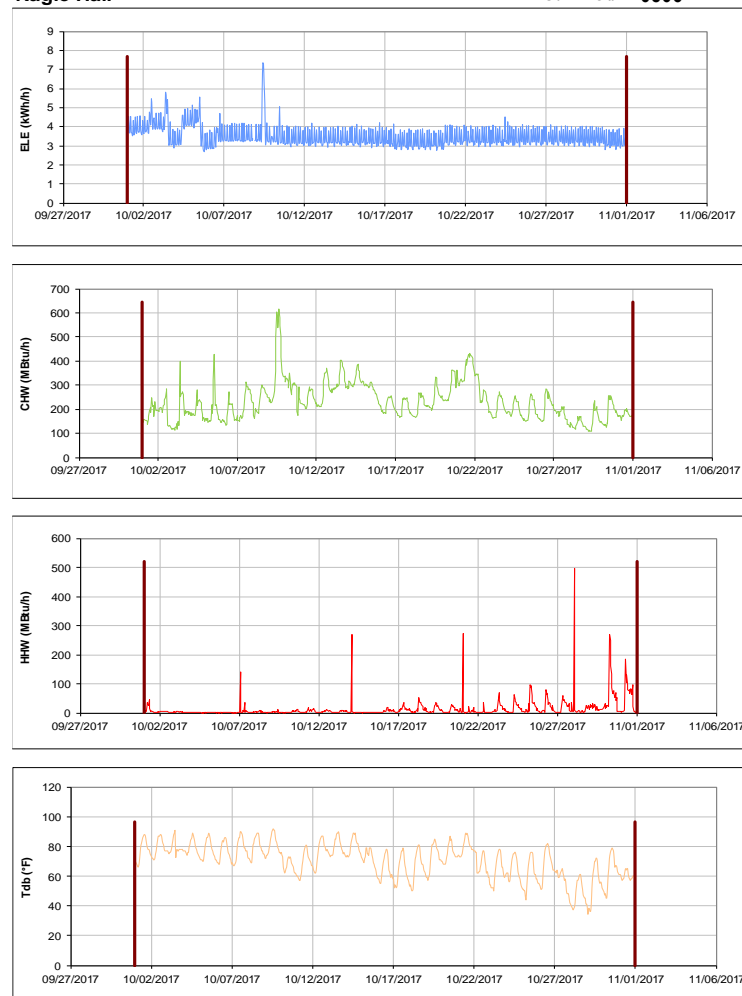
TAMU / BLDG #: 0506

Figure III-102 Hourly Whole Building Electricity, Chilled Water, and Hot Water Consumption for Nagle Hall during the Month of October 2017 and the Corresponding Hourly Outdoor Dry Bulb Temperature for College Station, TX

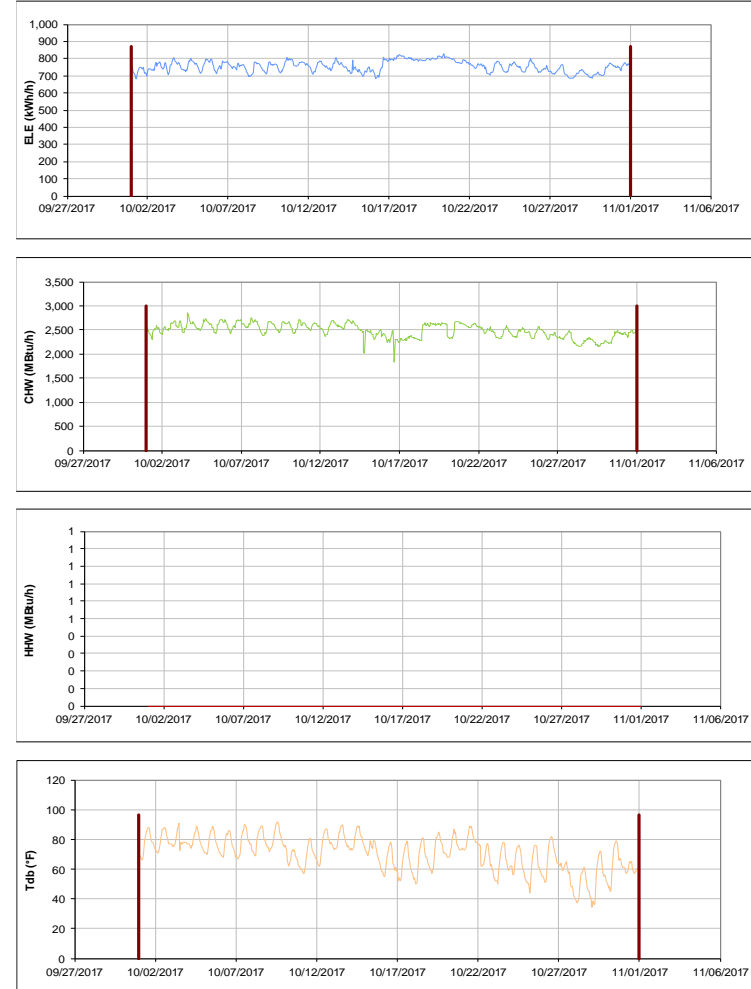
TAMU / BLDG #: 0516

Figure III-110 Hourly Whole Building Electricity, Chilled Water, and Hot Water Consumption for Computing Services Center during the Month of October 2017 and the Corresponding Hourly Outdoor Dry Bulb Temperature for College Station, TX

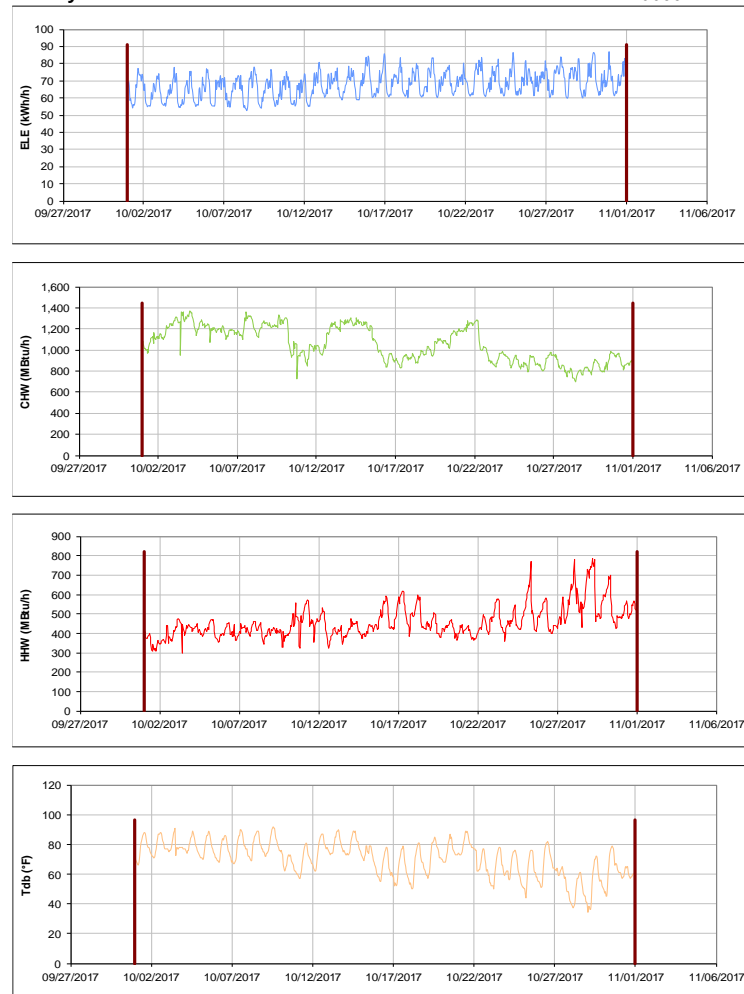
TAMU / BLDG #: 0653

Figure III-120 Hourly Whole Building Electricity, Chilled Water, and Hot Water Consumption for Hobby Residence Hall during the Month of October 2017 and the Corresponding Hourly Outdoor Dry Bulb Temperature for College Station, TX

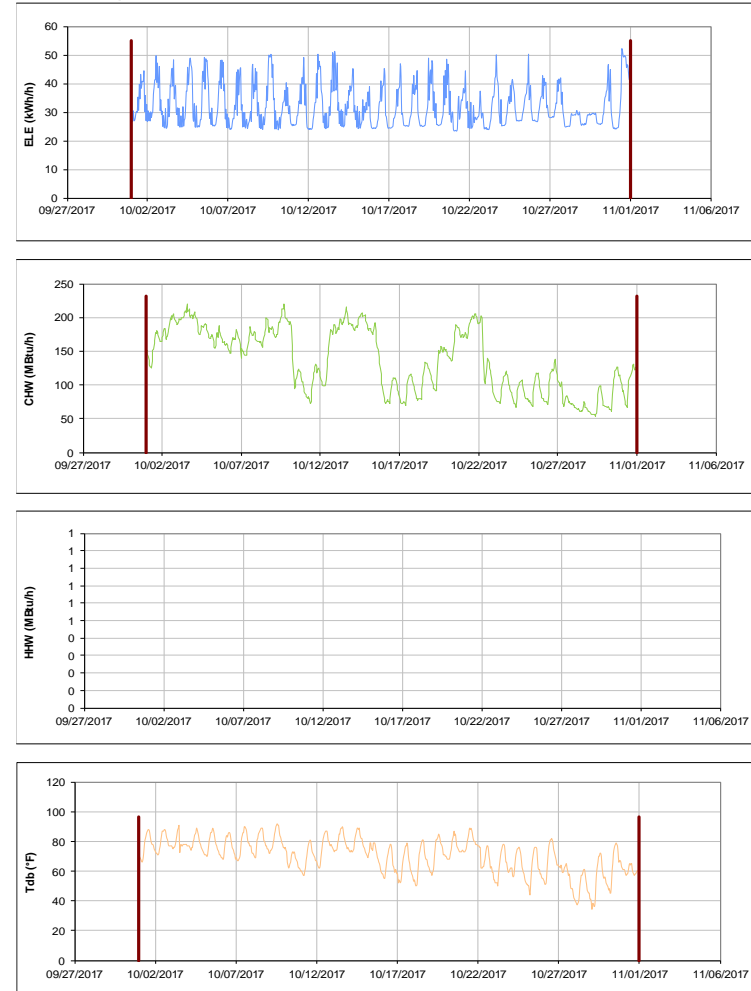
TAMU / BLDG #: 0815

Figure III-124 Hourly Whole Building Electricity, Chilled Water, and Hot Water Consumption for Entomology Research Lab during the Month of October 2017 and the Corresponding Hourly Outdoor Dry Bulb Temperature for College Station, TX

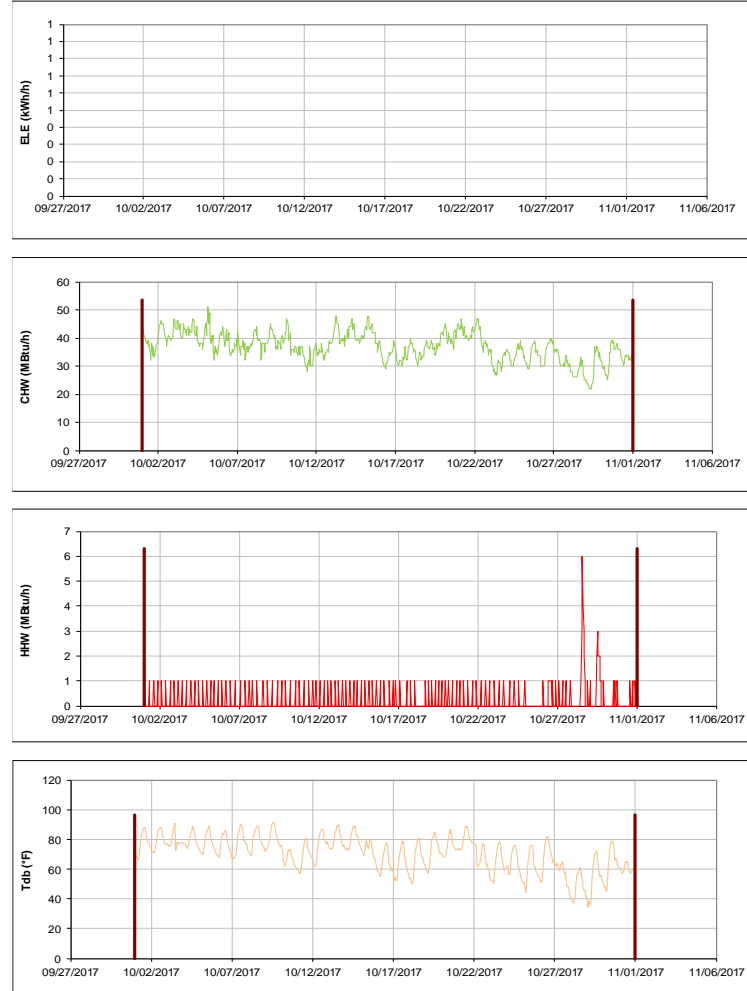
TAMU / BLDG #: 0880

Figure III-125 Hourly Whole Building Electricity, Chilled Water, and Hot Water Consumption for TVMC-Small Animal Building during the Month of October 2017 and the Corresponding Hourly Outdoor Dry Bulb Temperature for College Station, TX

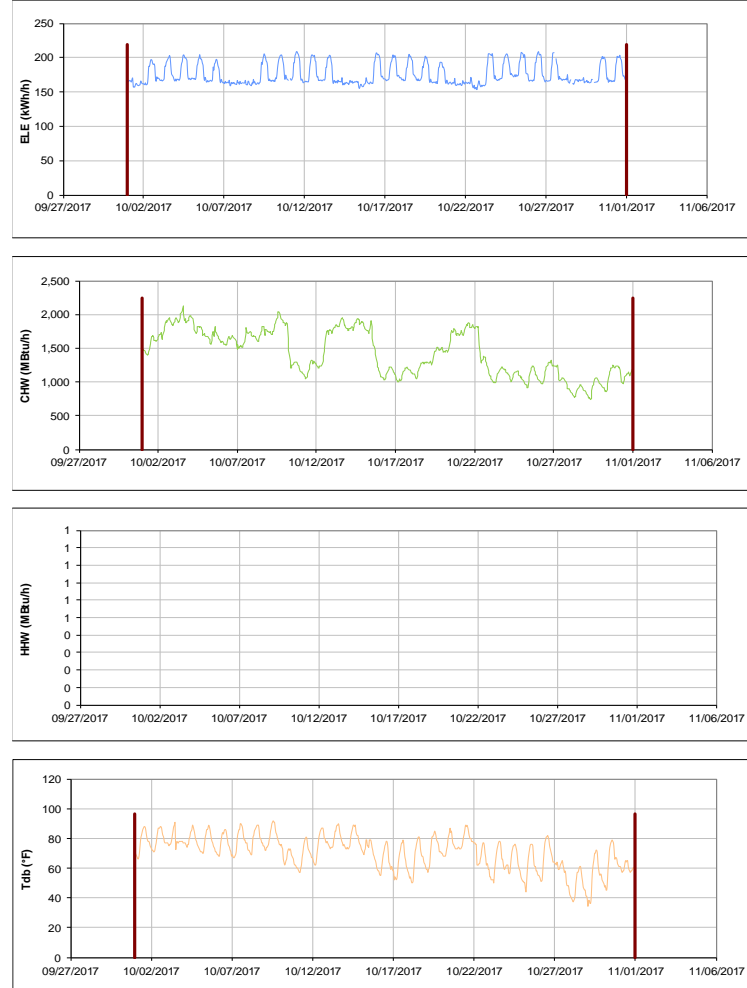
TAMU / BLDG #: 1026

Figure III-129 Hourly Whole Building Electricity, Chilled Water, and Hot Water Consumption for Veterinary Medicine Administration during the Month of October 2017 and the Corresponding Hourly Outdoor Dry Bulb Temperature for College Station, TX

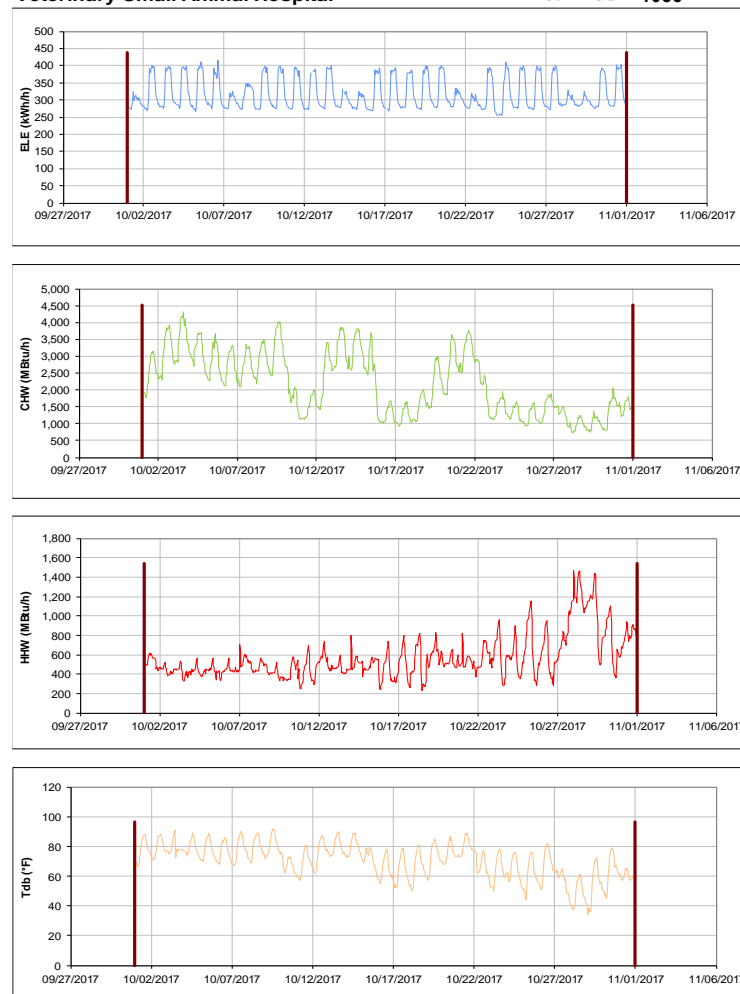
TAMU / BLDG #: 1085

Figure III-132 Hourly Whole Building Electricity, Chilled Water, and Hot Water Consumption for Veterinary Small Animal Hospital during the Month of October 2017 and the Corresponding Hourly Outdoor Dry Bulb Temperature for College Station, TX

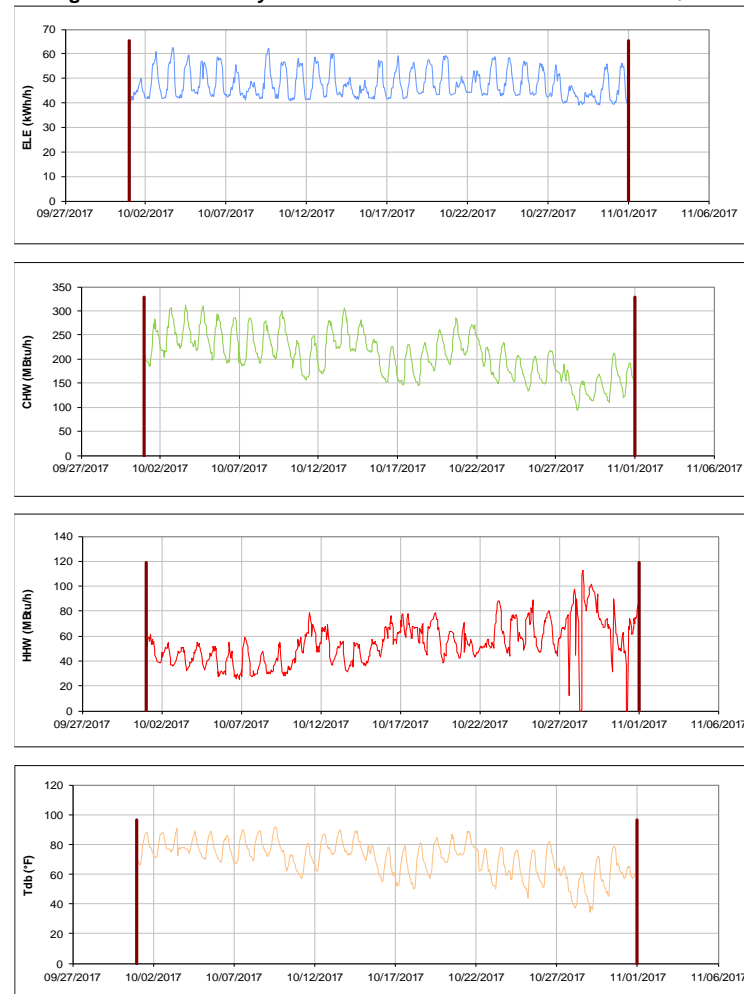
TAMU / BLDG #: 1146

Figure III-134 Hourly Whole Building Electricity, Chilled Water, and Hot Water Consumption for Biological Control Facility during the Month of October 2017 and the Corresponding Hourly Outdoor Dry Bulb Temperature for College Station, TX

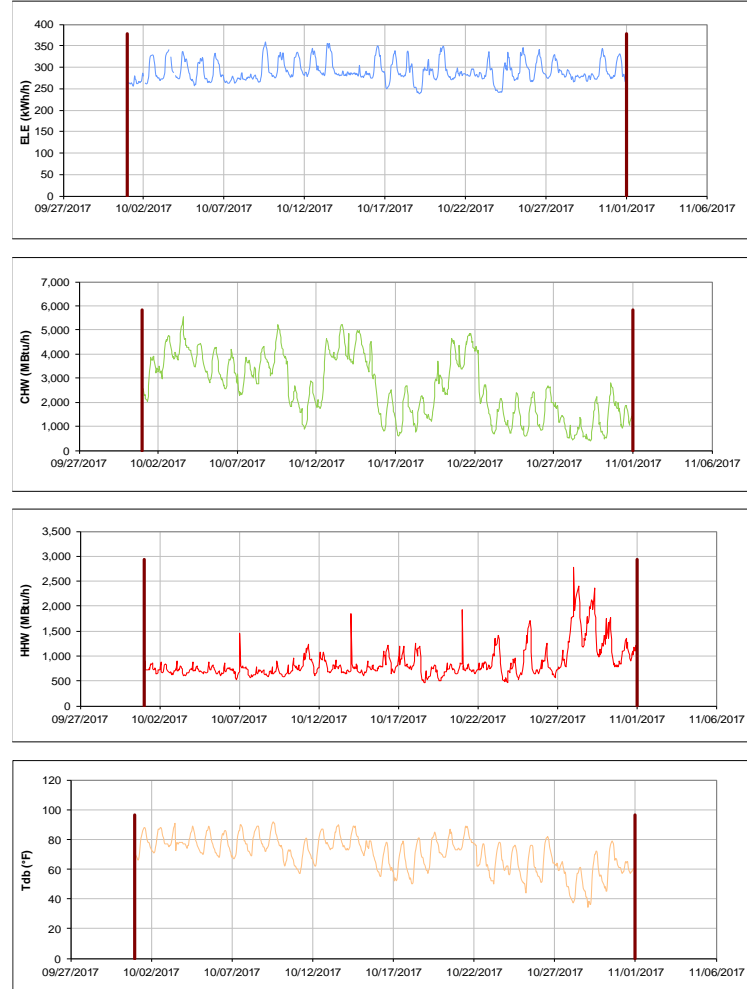
TAMU / BLDG #: 1194

Figure III-137 Hourly Whole Building Electricity, Chilled Water, and Hot Water Consumption for Veterinary Large Animal Hospital during the Month of October 2017 and the Corresponding Hourly Outdoor Dry Bulb Temperature for College Station, TX

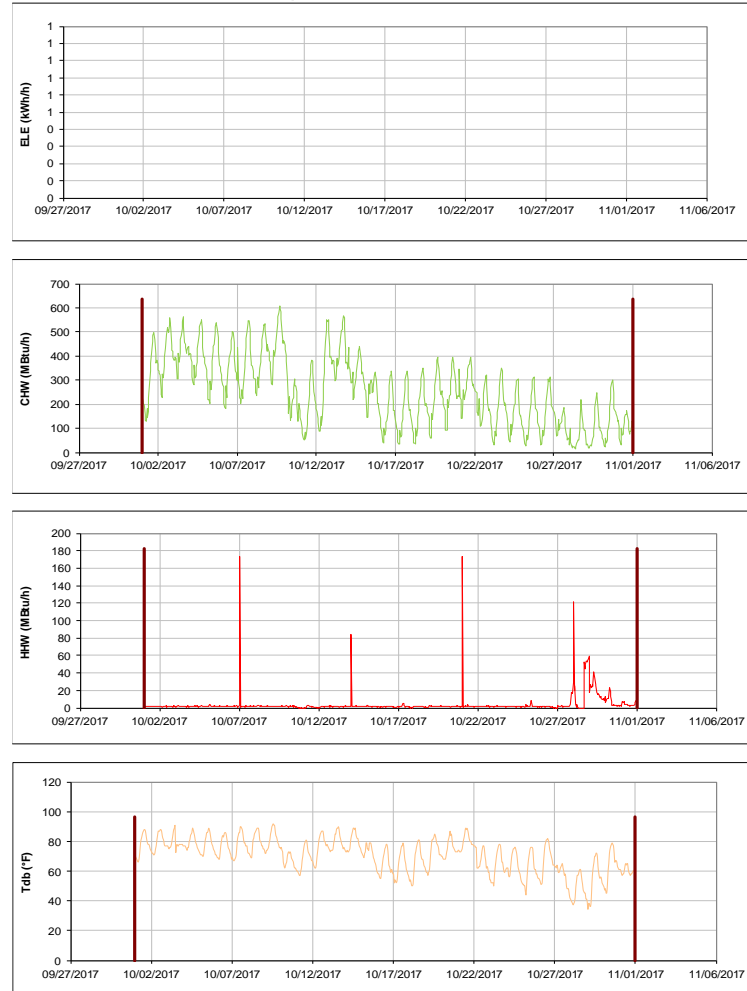
TAMU / BLDG #: 1402

Figure III-139 Hourly Whole Building Electricity, Chilled Water, and Hot Water Consumption for Buzbee Leadership Learning Center during the Month of October 2017 and the Corresponding Hourly Outdoor Dry Bulb Temperature for College Station, TX

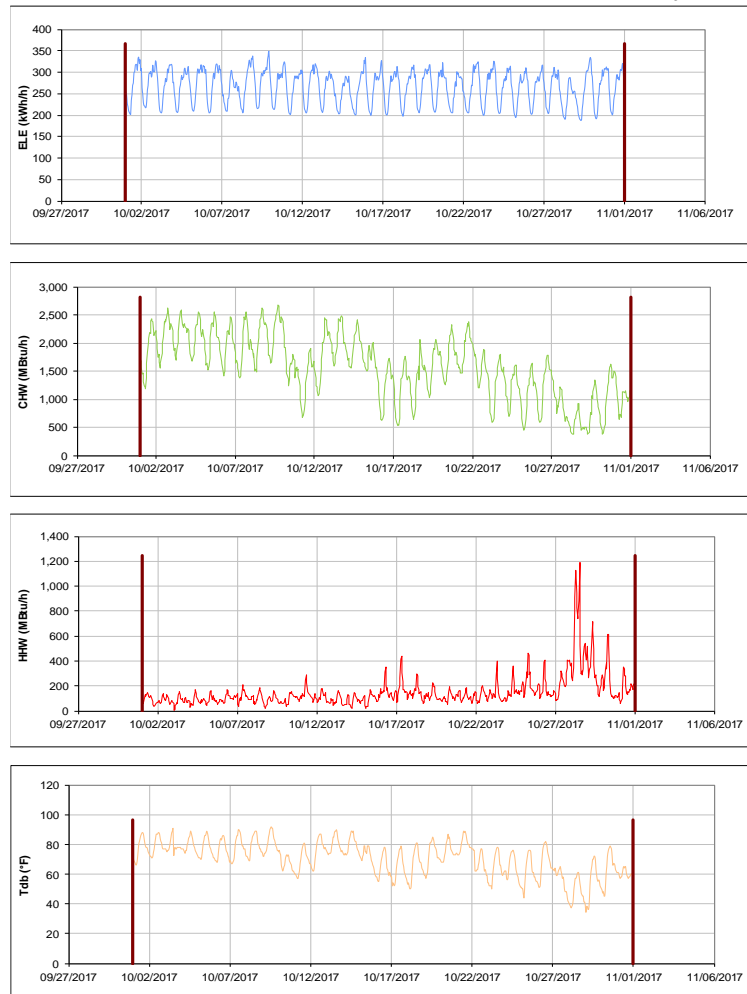
TAMU / BLDG #: 1416

Figure III-143 Hourly Whole Building Electricity, Chilled Water, and Hot Water Consumption for Hullabaloo Residence Hall during the Month of October 2017 and the Corresponding Hourly Outdoor Dry Bulb Temperature for College Station, TX

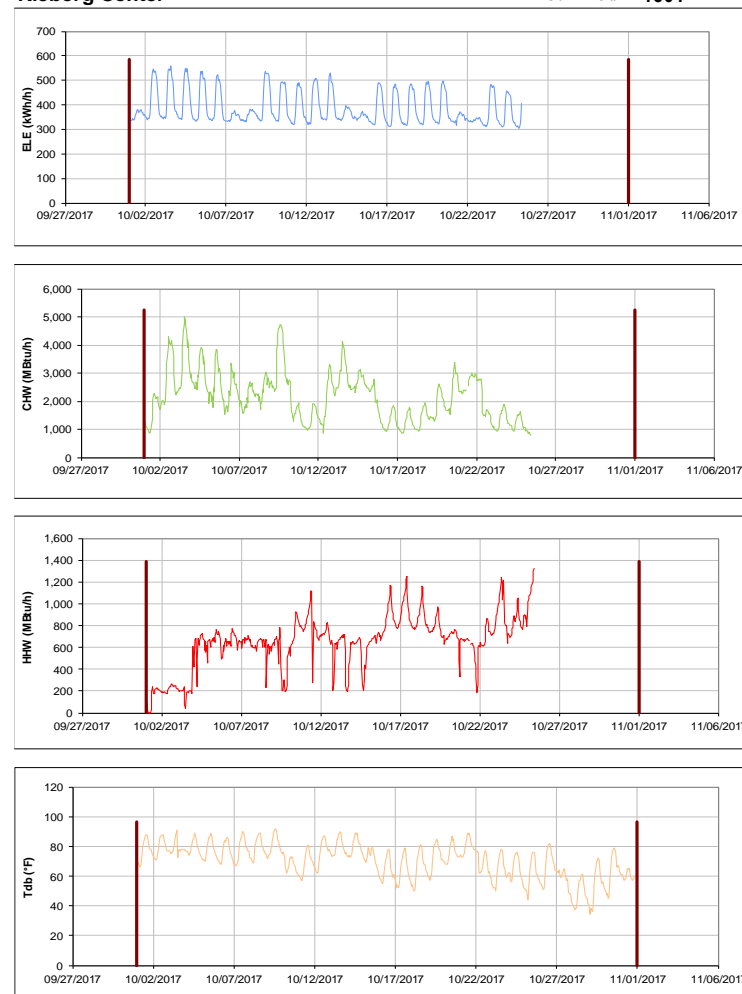
TAMU / BLDG #: 1501

Figure III-156 Hourly Whole Building Electricity, Chilled Water, and Hot Water Consumption for Kleberg Center during the Month of October 2017 and the Corresponding Hourly Outdoor Dry Bulb Temperature for College Station, TX

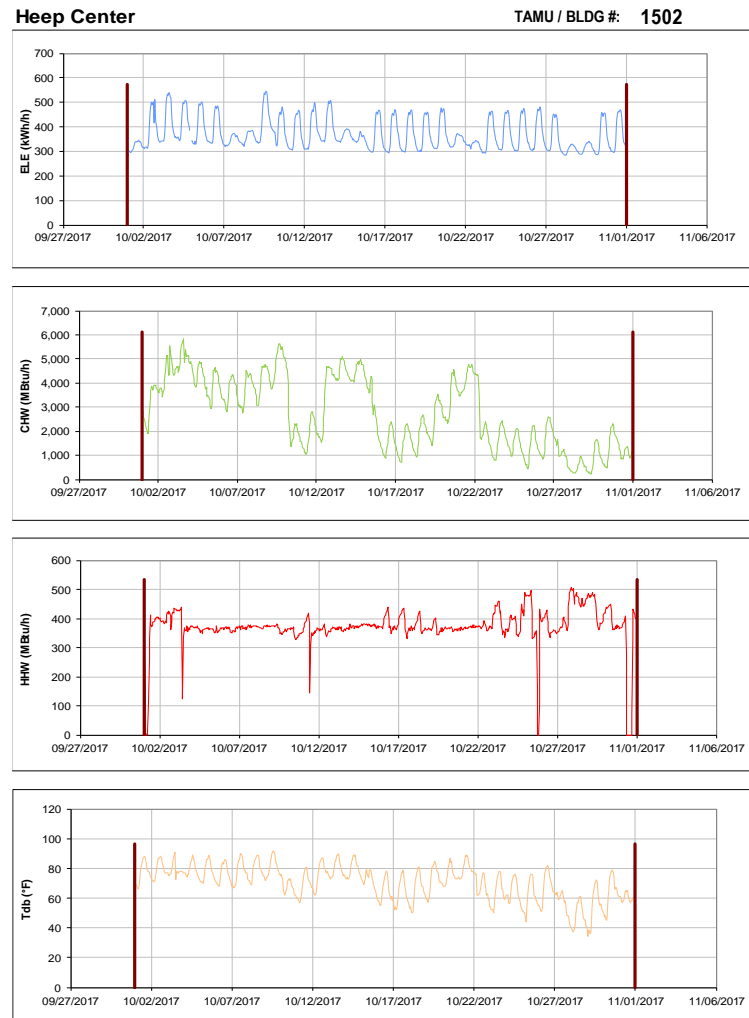
Figure III-157 Hourly Whole Building Electricity, Chilled Water, and Hot Water Consumption for Heep Center during the Month of October 2017 and the Corresponding Hourly Outdoor Dry Bulb Temperature for College Station, TX

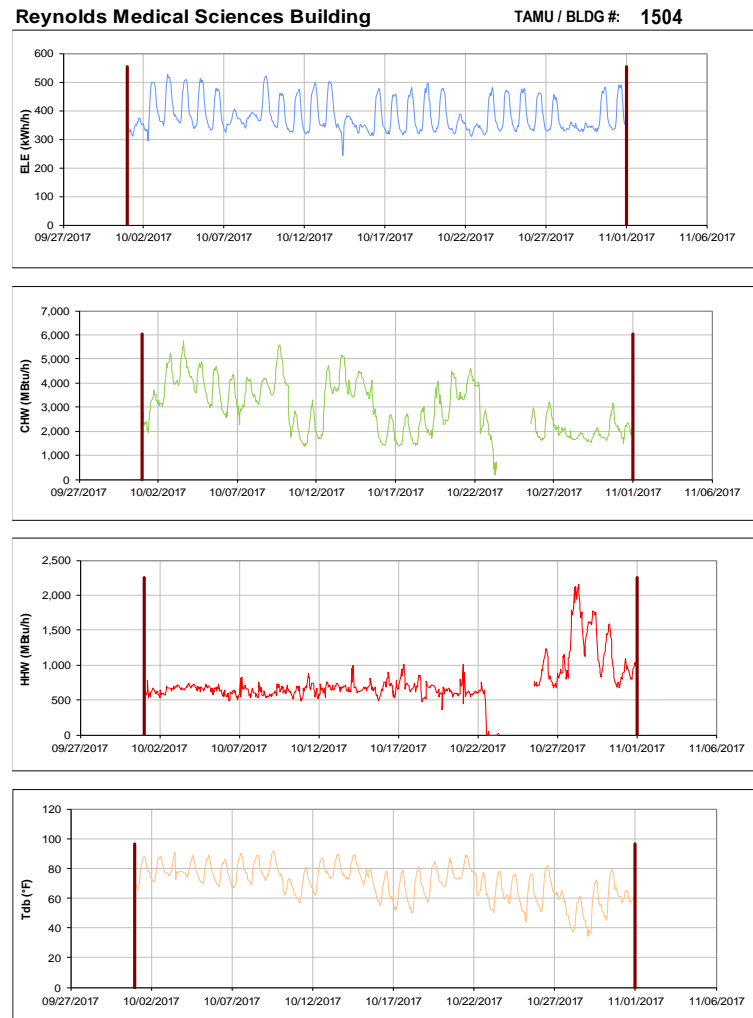
Figure III-159 Hourly Whole Building Electricity, Chilled Water, and Hot Water Consumption for Reynolds Medical Sciences Building during the Month of October 2017 and the Corresponding Hourly Outdoor Dry Bulb Temperature for College Station, TX

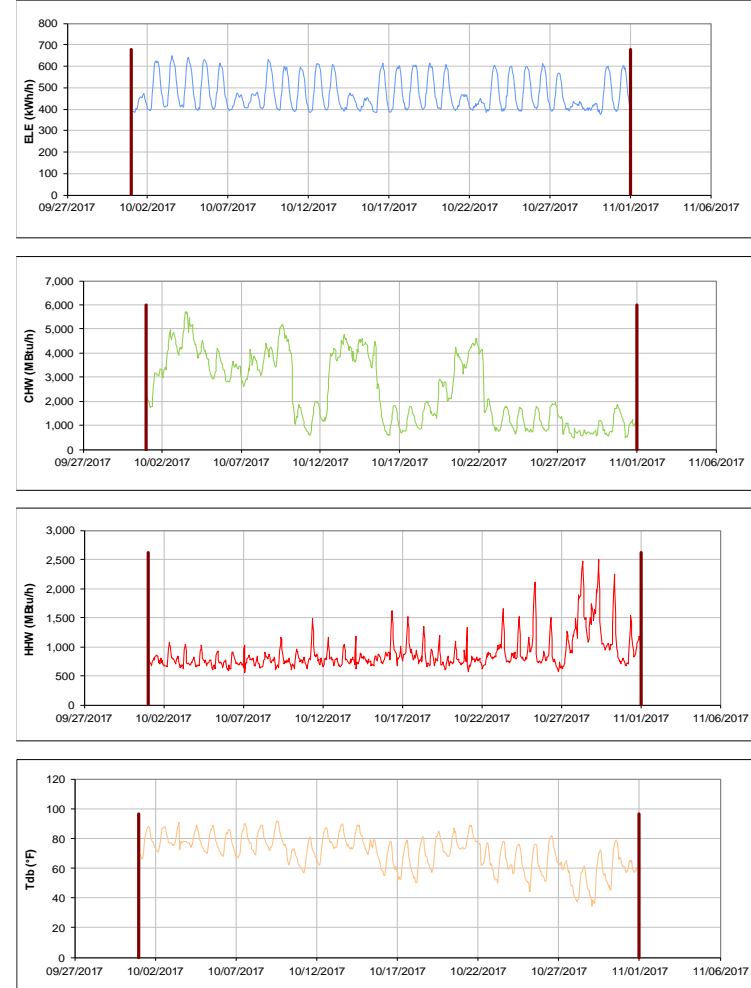
TAMU / BLDG #: 1507

Figure III-162 Hourly Whole Building Electricity, Chilled Water, and Hot Water Consumption for Biochemistry-Biophysics Building during the Month of October 2017 and the Corresponding Hourly Outdoor Dry Bulb Temperature for College Station, TX

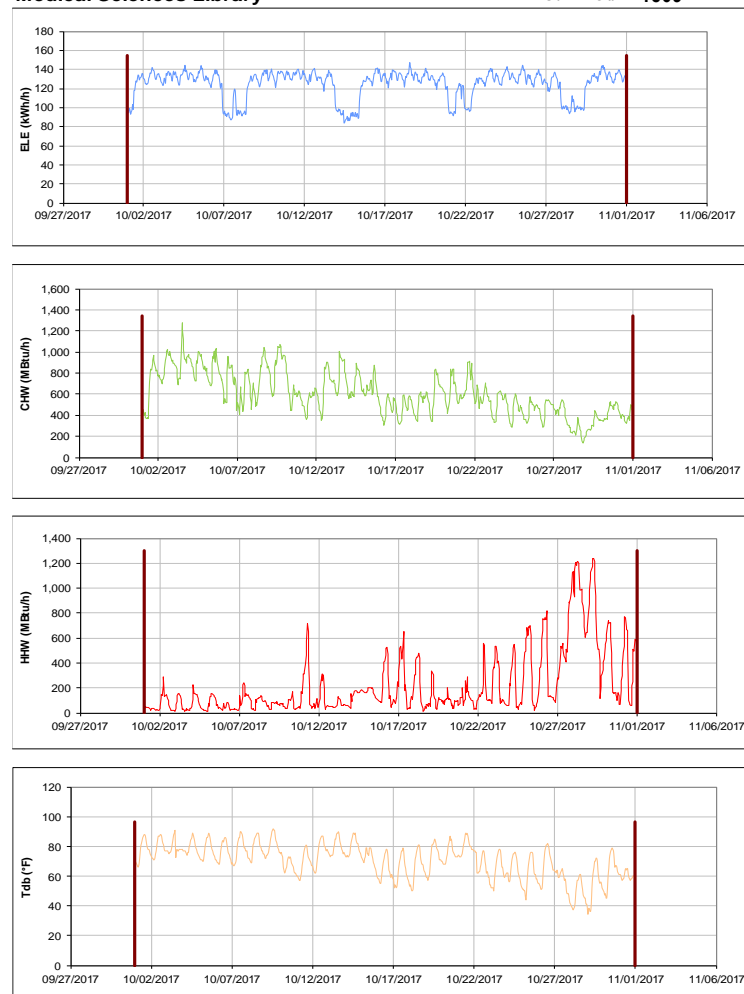
Medical Sciences Library TAMU / BLDG #: 1509

Figure III-164 Hourly Whole Building Electricity, Chilled Water, and Hot Water Consumption for Medical Sciences Library during the Month of October 2017 and the Corresponding Hourly Outdoor Dry Bulb Temperature for College Station, TX

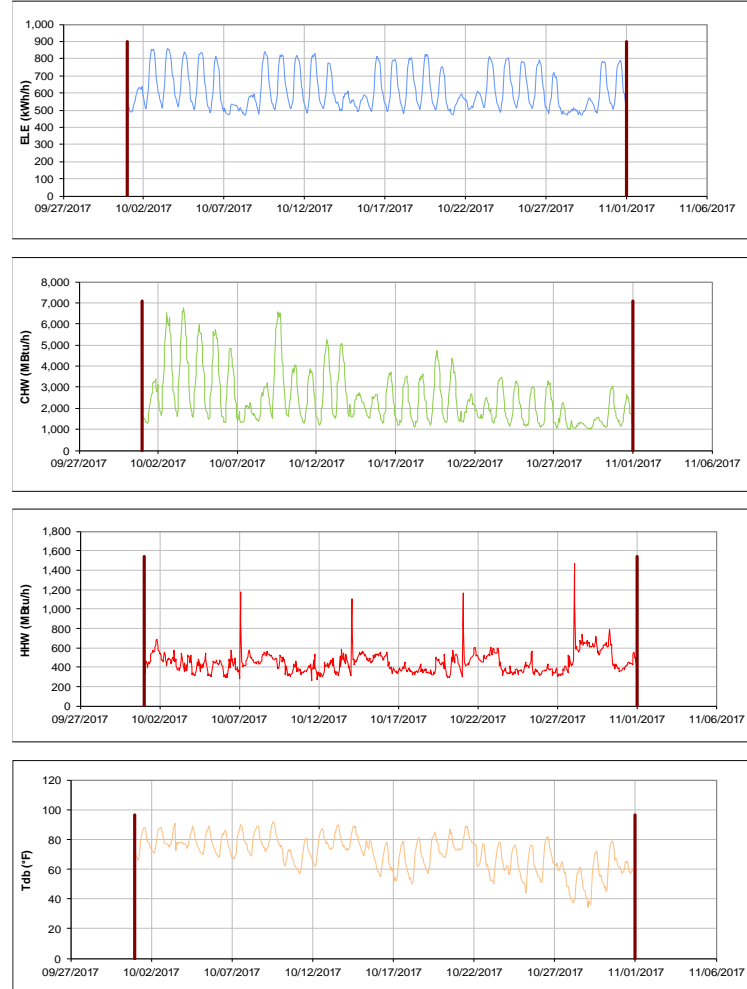
TAMU / BLDG #: 1510

Figure III-165 Hourly Whole Building Electricity, Chilled Water, and Hot Water Consumption for Wehner Building during the Month of October 2017 and the Corresponding Hourly Outdoor Dry Bulb Temperature for College Station, TX

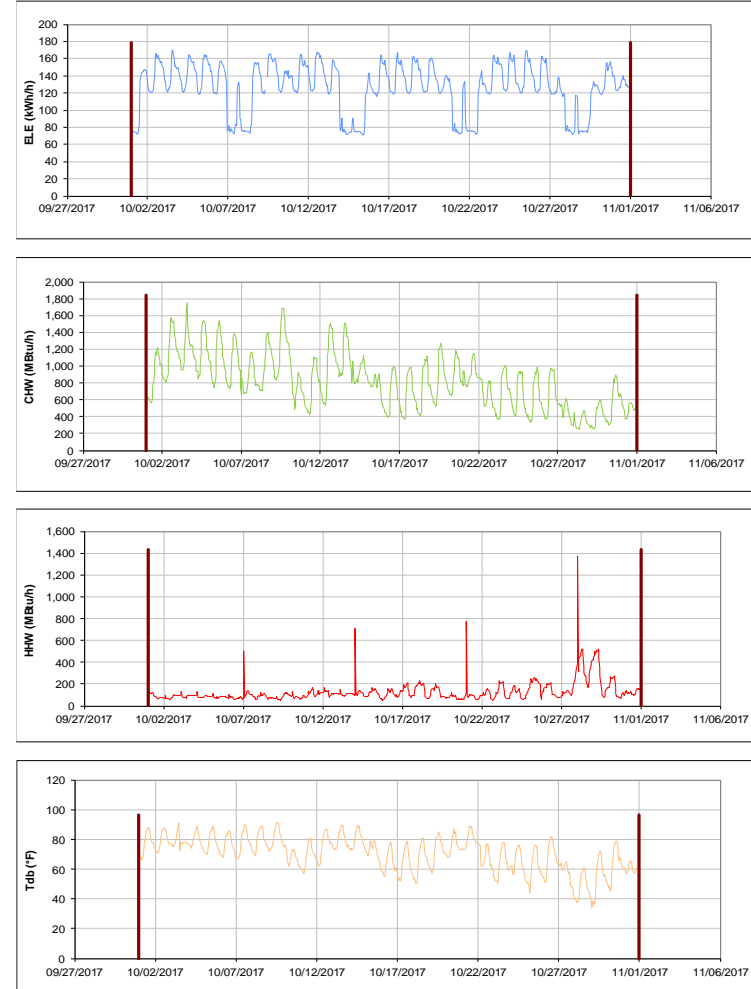
TAMU / BLDG #: 1511

Figure III-166 Hourly Whole Building Electricity, Chilled Water, and Hot Water Consumption for West Campus Library Facility during the Month of October 2017 and the Corresponding Hourly Outdoor Dry Bulb Temperature for College Station, TX

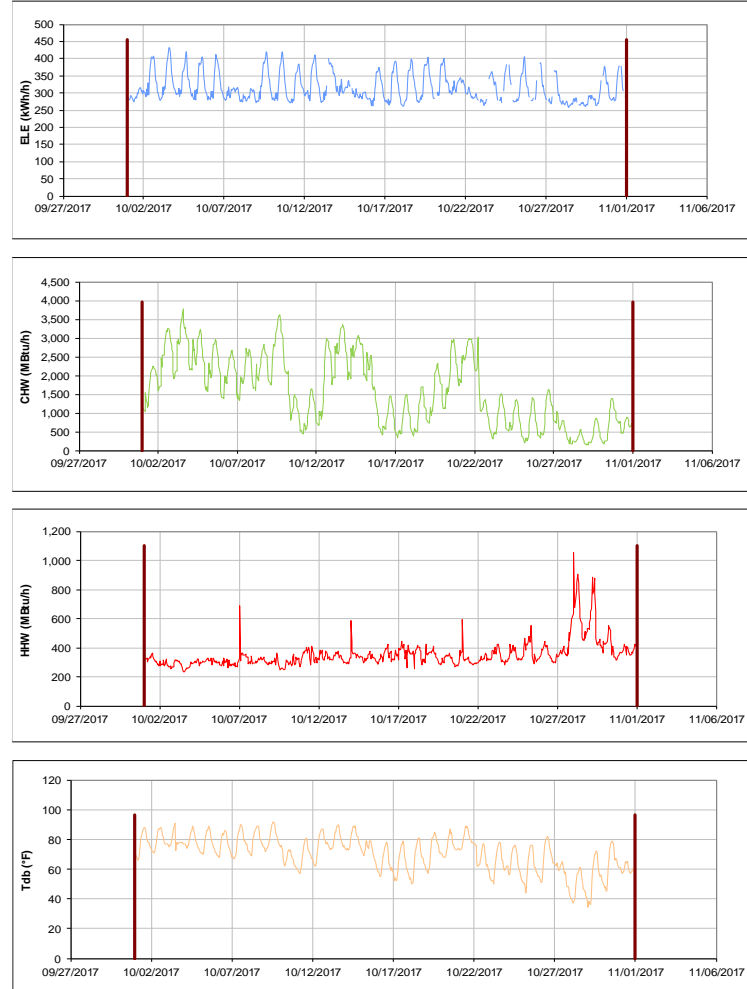
TAMU / BLDG #: 1518

Figure III-169 Hourly Whole Building Electricity, Chilled Water, and Hot Water Consumption for TX School of Rural Public Health during the Month of October 2017 and the Corresponding Hourly Outdoor Dry Bulb Temperature for College Station, TX
